Rattle Noise from Automatic Transmission Control Cable Assembly in Reverse

YEAR(S)	MODEL(S)	ADDITIONAL INFORMATION
2007 – 2009	Yaris	Transmission(s): 4AT

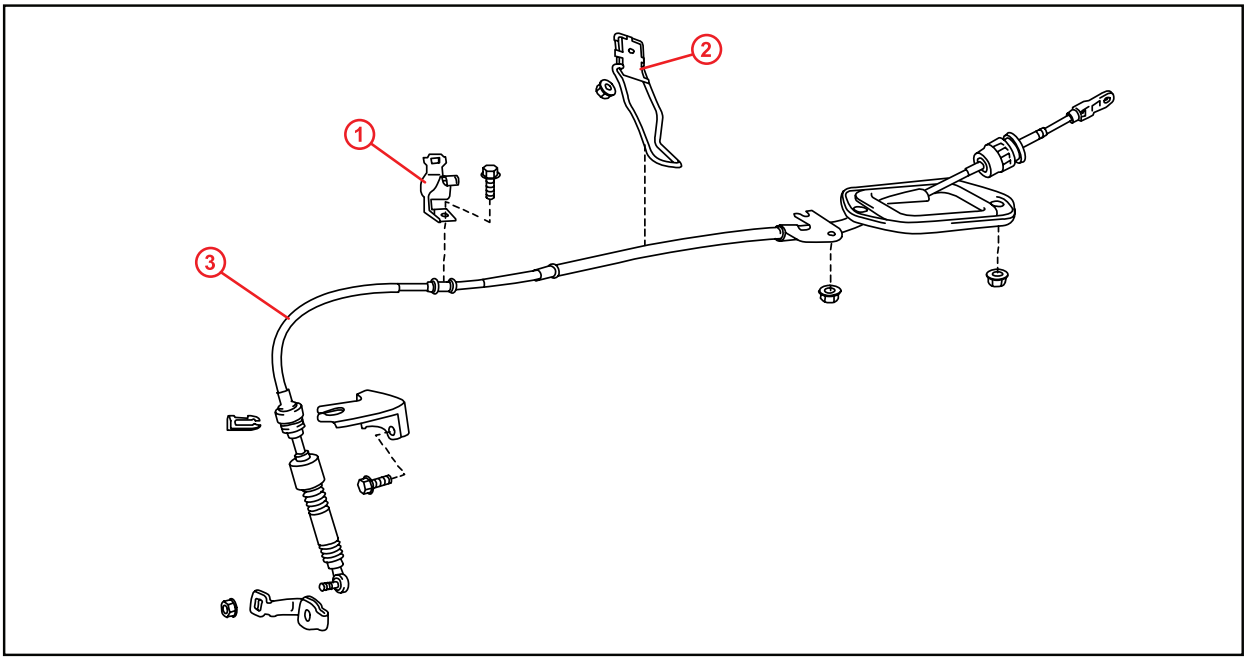
Figure 1.

Some 2007 – 2009 model year Yaris vehicles may exhibit a rattle noise from the engine compartment with engine speed above idle and the automatic transmission shift lever position in reverse. Follow the repair procedure below to address this condition.

1. Raise the vehicle and locate the No. 2 transmission control cable support to the left of the center exhaust pipe flange.
2. Using the plastic clamp, secure the automatic transmission control cable assembly to the No. 2 transmission control cable support. Refer to Figure 1 for the location.
